# Service Bulletin

## Faulty Door Sensor Setup Leading to Charging Disruptions

### Power Link 1000

**Bulletin Published:** December, 2025

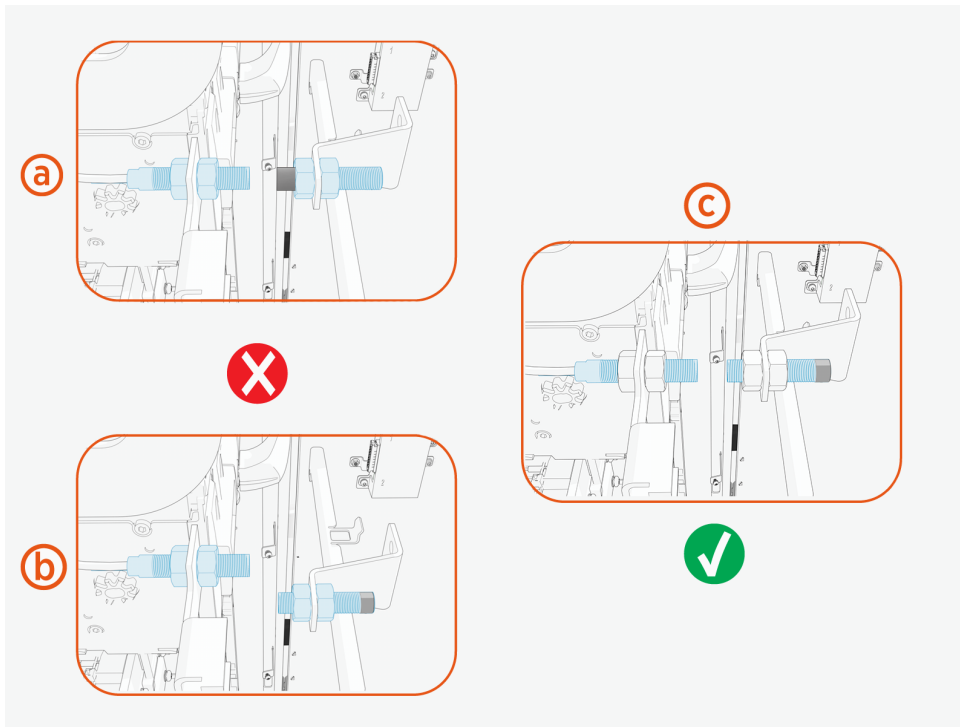
- The magnet is oriented backwards, where potting side is facing the sensor.
- The magnet is too far from the reed sensor
- The reed sensor Molex connector is loose or damaged

1. Make sure the magnet and sensor are aligned in the correct orientation, refer to the following image.

- (a) **Incorrect:** The potting side of the magnet faces the threaded side of the sensor.
- (b) **Incorrect:** The magnet and sensor are misaligned, their threaded ends do not face each other.
- (c) **Correct:** The threaded side of the magnet and the threaded side of the sensor face each other and are properly aligned.

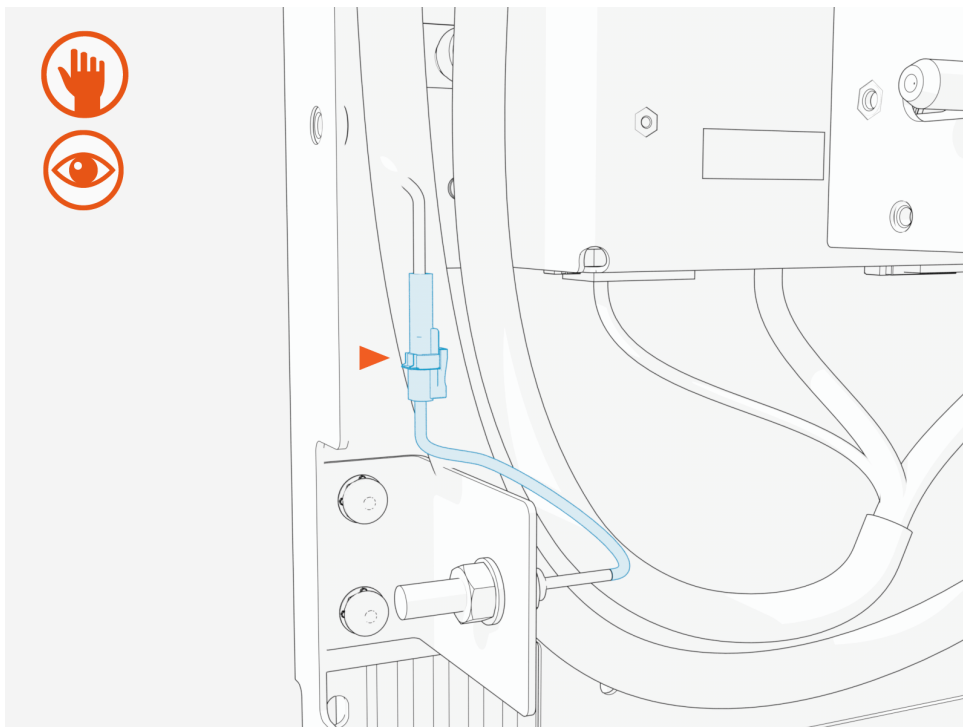
- 
2. Inspect the Molex connector for bent pins, corrosion, or loose fit.

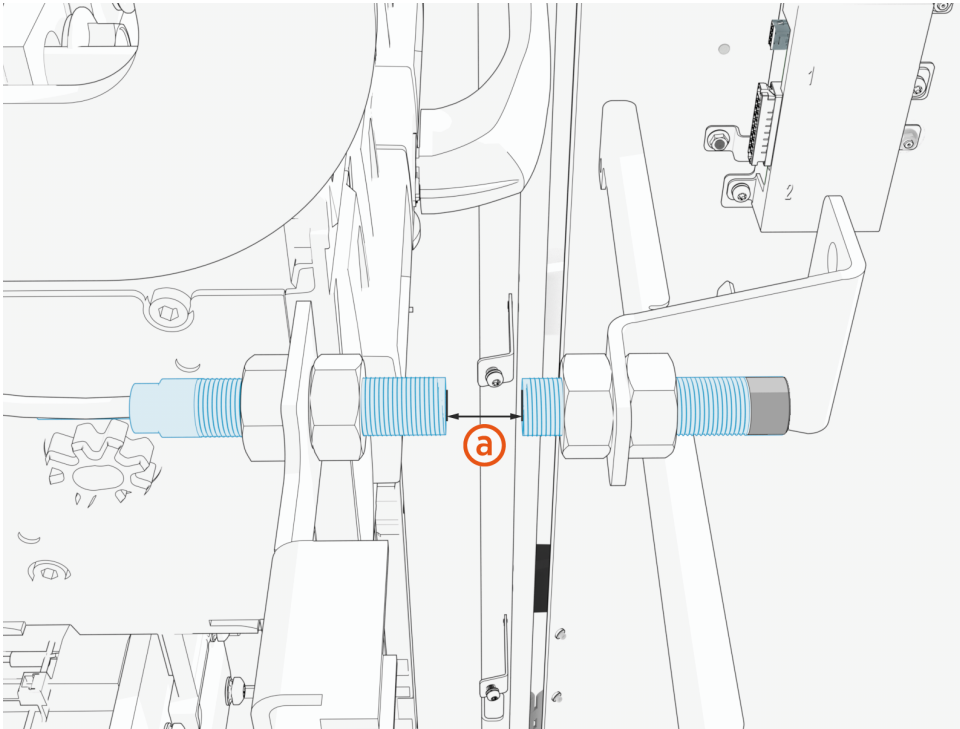
3. Measure the gap **(a)** between the threaded sides of the sensor and magnet, and ensure the gap is less than 10 mm and as close as possible.

**NOTE:** If needed, replace standard M8 nuts (x2) with the thin M8 nuts (x2) on both sides of the magnet to reduce the gap **(a)**.
