Service Bulletin

Faulty Door Sensor Setup Leading to Charging Disruptions

Power Link 2000

Bulletin Published: November, 2025

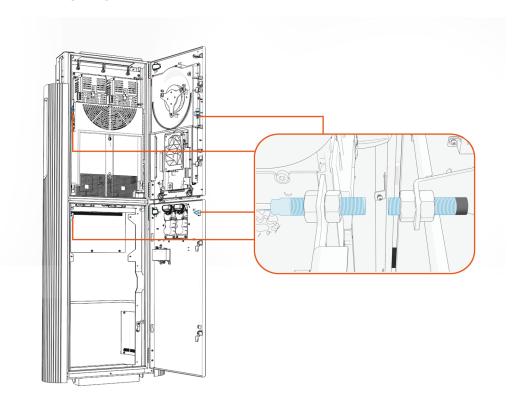
The following image shows the location of the door sensors in the Power Link 2000.

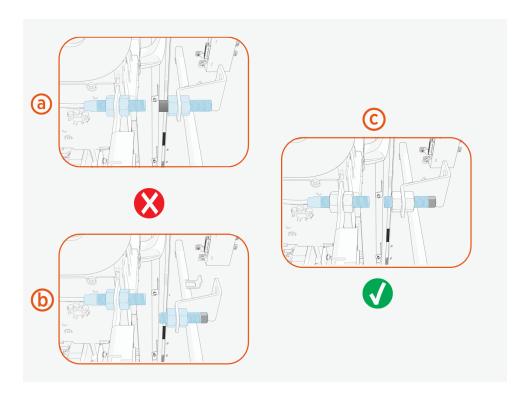
- The magnet is oriented backwards, where potting side is facing the sensor.
- · The magnet is too far from the reed sensor
- The reed sensor Molex connector is loose or damaged

- (a) Incorrect: The potting side of the magnet faces the threaded side of the sensor.
- (b) Incorrect: The magnet and sensor are misaligned, their threaded ends do not face each other.
- (c) **Correct:** The threaded side of the magnet and the threaded side of the sensor face each other and are properly aligned.

1. Make sure the magnet and sensor are aligned in the correct orientation, refer to the following image.
