# Service Bulletin

## Faulty Door Sensor Setup Leading to Charging Disruptions

### Power Link 1000

**Bulletin Published:** December, 2025

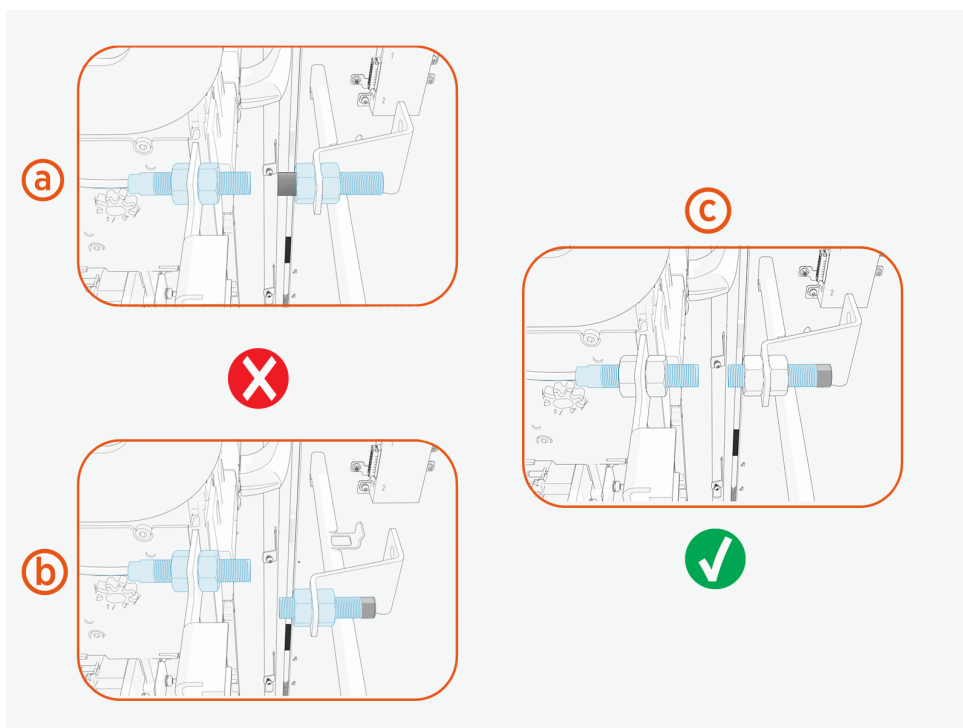
- The magnet is oriented backwards, where potting side is facing the sensor.
- The magnet is too far from the reed sensor
- The reed sensor Molex connector is loose or damaged

- (a) **Incorrect:** The potting side of the magnet faces the threaded side of the sensor.
- (b) **Incorrect:** The magnet and sensor are misaligned, their threaded ends do not face each other.
- (c) **Correct:** The threaded side of the magnet and the threaded side of the sensor face each other and are properly aligned.

1. Make sure the magnet and sensor are aligned in the correct orientation, refer to the following image.
