# Service Bulletin

## Faulty Door Sensor Setup Leading to Charging Disruptions

### Power Link 2000

**Bulletin Published:** November, 2025

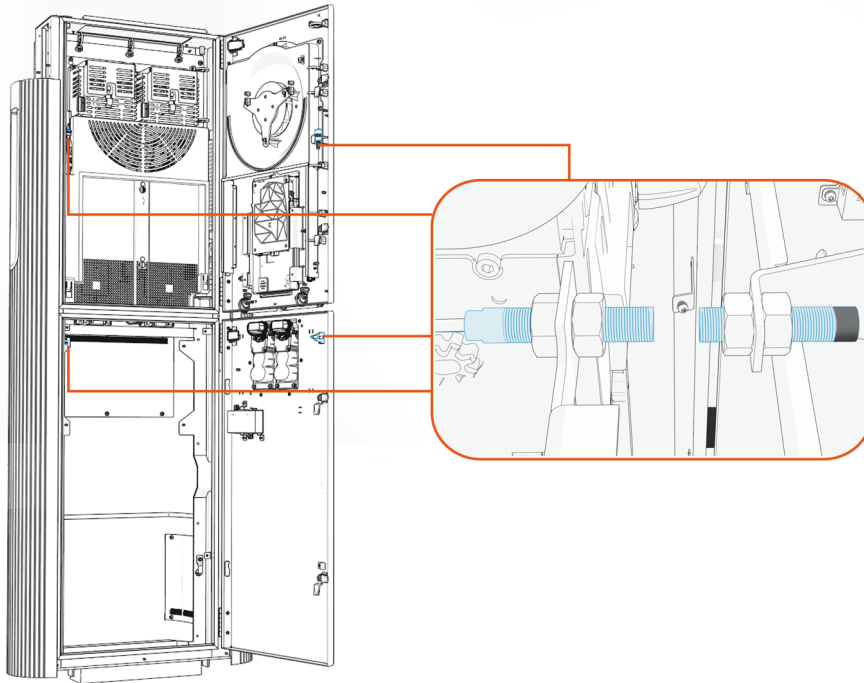
Some DC charging stations may not detect door closure correctly. This can stop charging, cause system faults, and delay deployment.

The following image shows the location of the door sensors in the Power Link 2000.

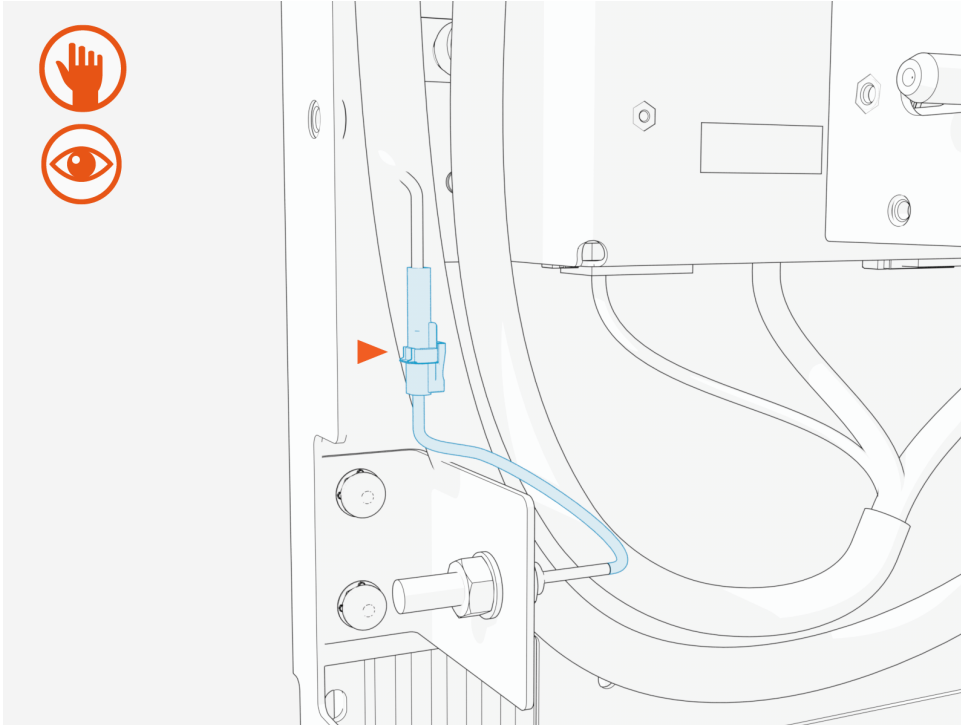
- 
2. Inspect the Molex connector for bent pins, corrosion, or loose fit.

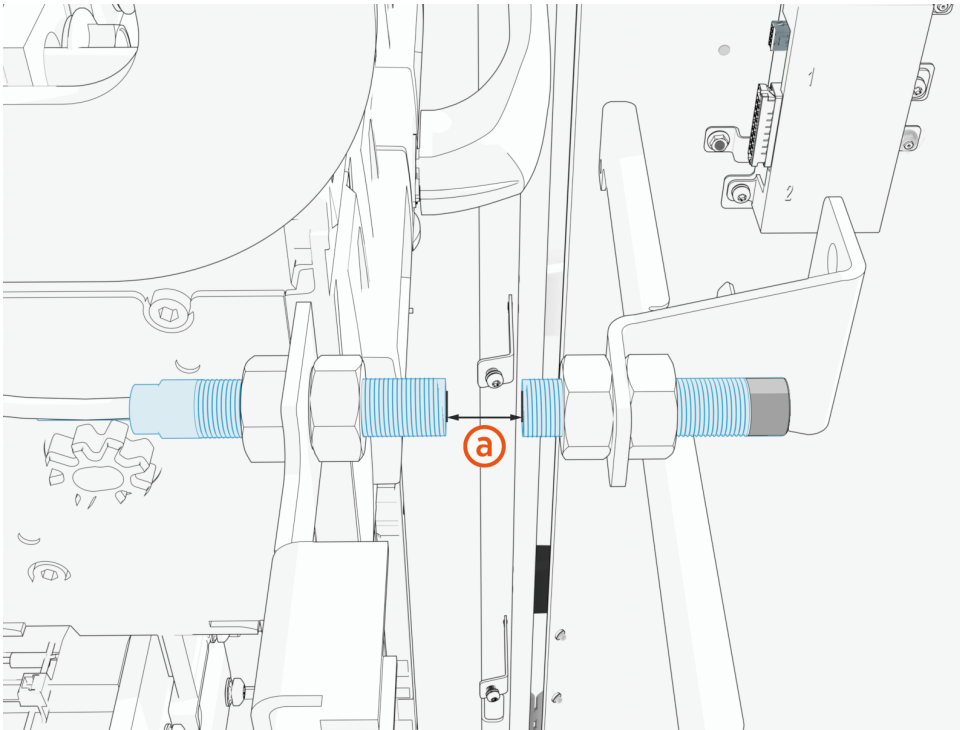
3. Measure the gap (a) between the threaded sides of the sensor and magnet, and ensure the gap is less than 10 mm and as close as possible.

**NOTE:** If needed, replace standard M8 nuts (x2) with the thin M8 nuts (x2) on both sides of the magnet to reduce the gap (a).
