# Service Bulletin

## Faulty Door Sensor Setup Leading to Charging Disruptions

### Power Link 1000

**Bulletin Published:** December, 2025

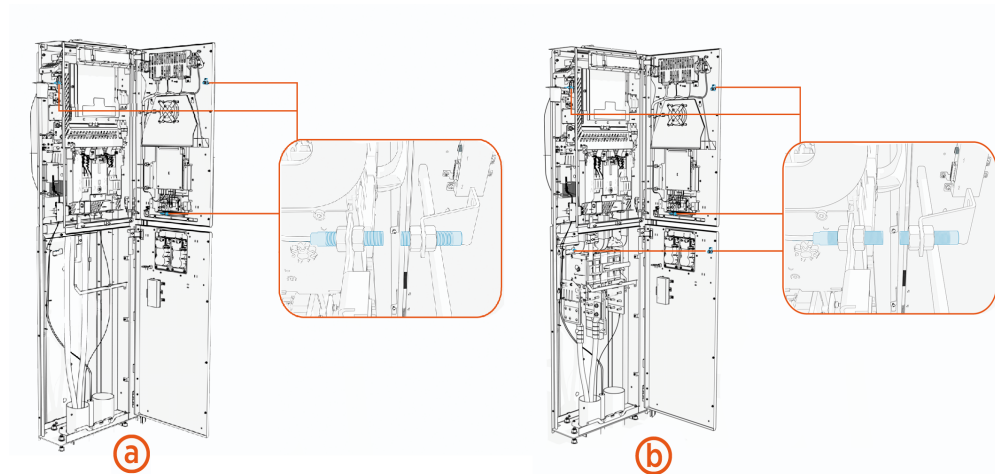
The following image shows the location of the door sensors in the Power Link 1000.

**(a)** Without Disconnect Kit

**(b)** With Disconnect Kit
