Express Plus

DC Fast Charging Platform

Operation and Maintenance Guide

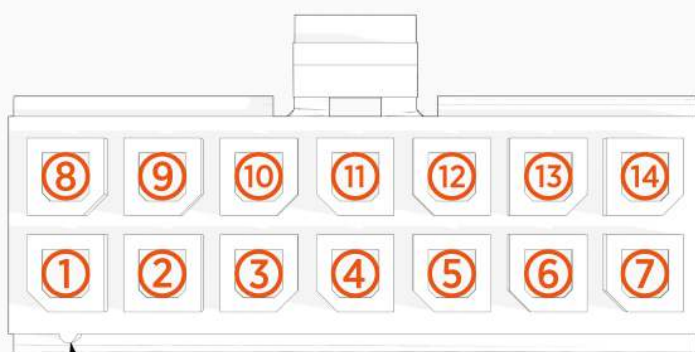
P306-10

Rib to identify the first circuit (pin)

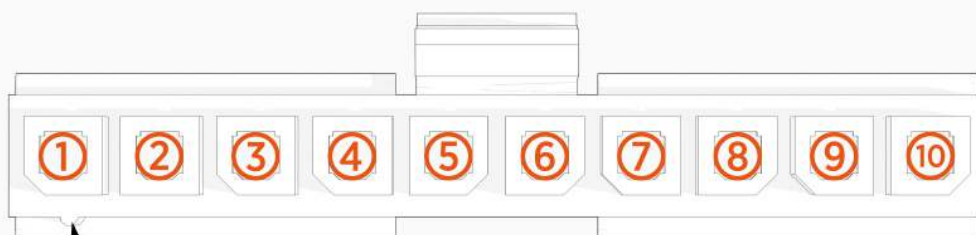
P306-15

Rib to identify the first circuit (pin)

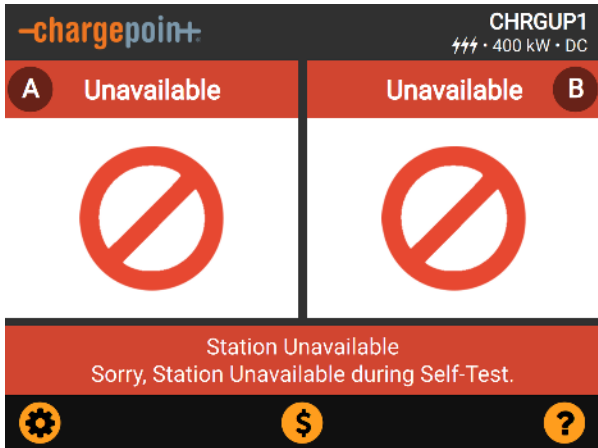
The image shows a ChargePoint station interface for a 400 kW DC station (CHRGUP1). The top bar is black with the ChargePoint logo and station details. Below it, two red buttons labeled 'A' and 'B' both say 'Unavailable'. In the center, there are two large red prohibition signs. At the bottom, a red banner reads 'Station Unavailable' and 'Sorry, Station Unavailable during Self-Test.' Below the banner is a black bar with three yellow icons: a gear, a dollar sign, and a question mark.

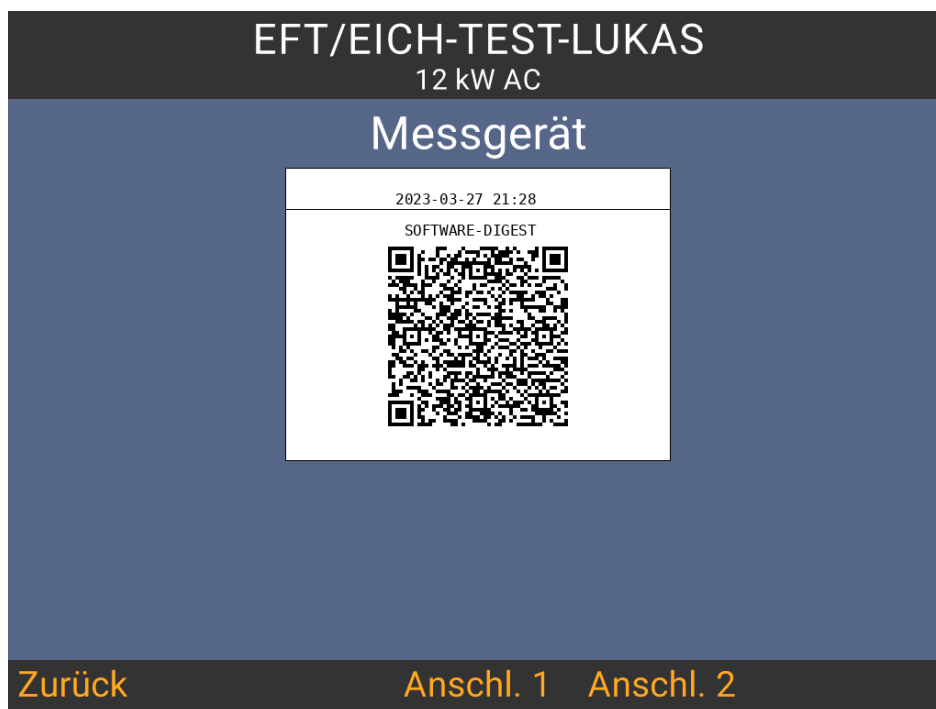
Software Digest

To access, click **Settings (gear wheel) > Energy Meter > Station** on the station display.

The legally relevant information is in the middle in the framed box. The time stamp appears first followed by the QR code for the LRS version of the charging station.

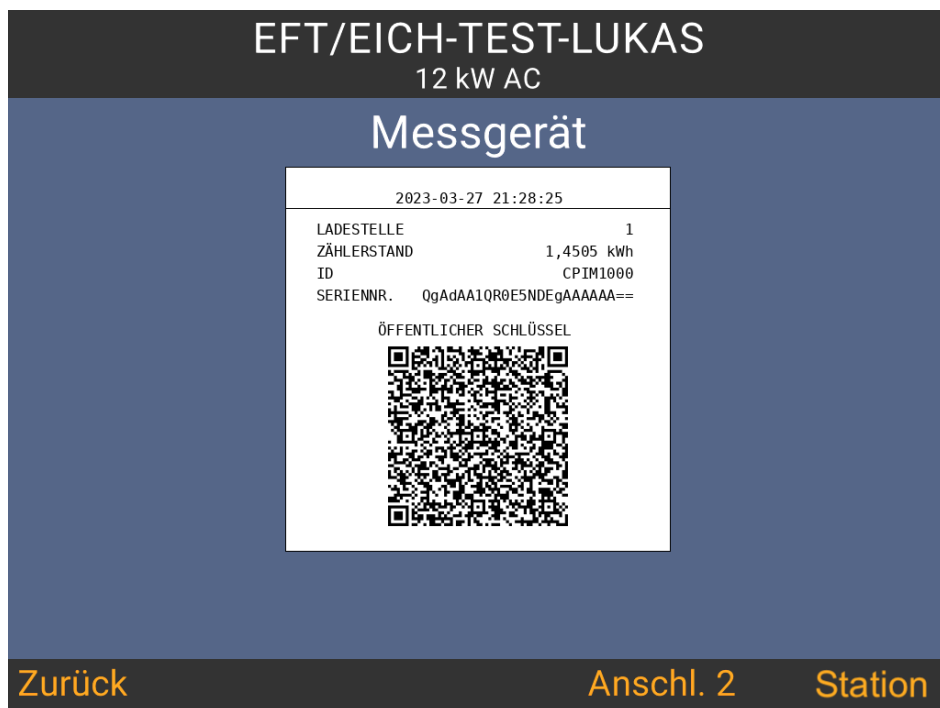
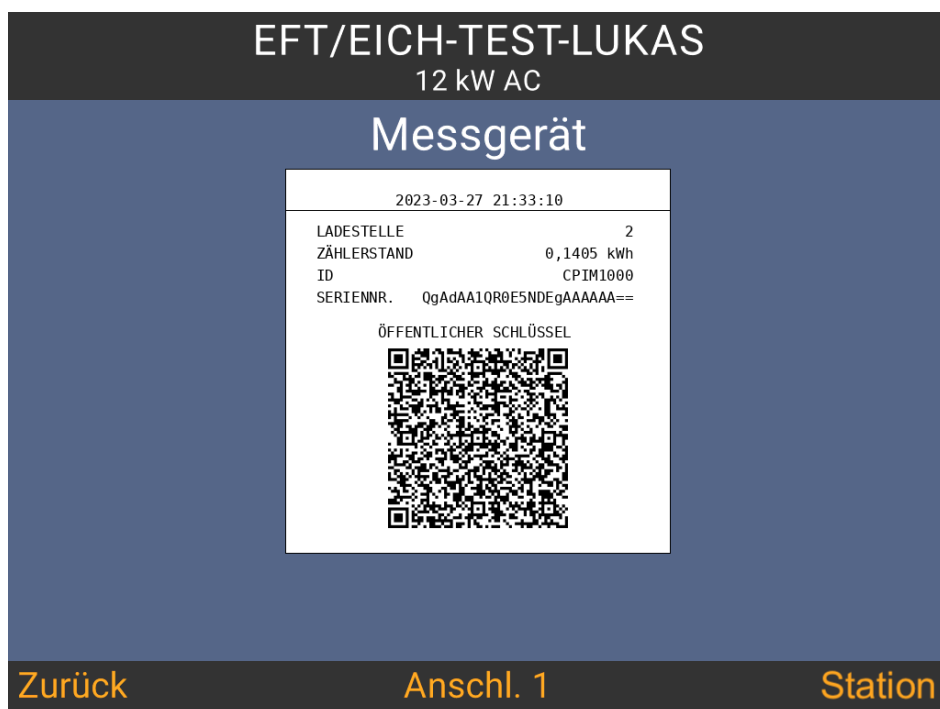
CDR Signing Public Key

To access, click **Settings (gear wheel) > Energy Meter**.

Each charging station has a unique public key. It is displayed as a QR code after pressing "Anschl. 1" or "Anschl. 2". It is used for all charging points of a charging station (up to two ports). To identify which charging point was used for a charging session on a charging station with two ports, see the generated OCMF and the field called "CI" (ChargePoint-Identification according to OCMF specification). The number "1" equals the left charging point, the number "2" the right one.

The legally relevant information is in the middle in the framed box. The time stamp appears first followed by the information on the selected charging point.

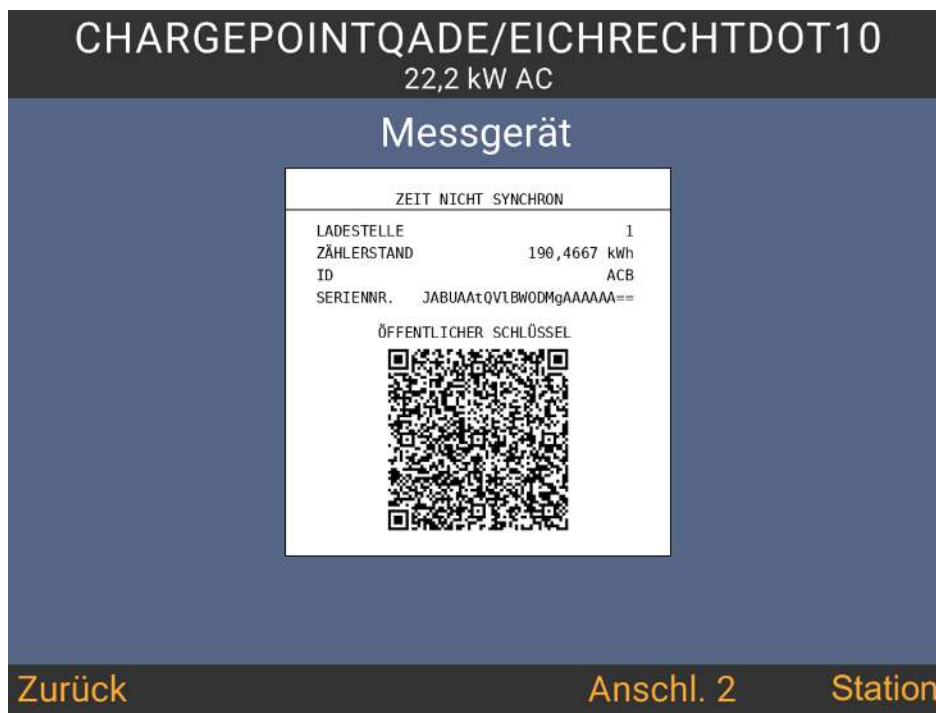
Time Sync Display

Each LRD (legally relevant display) Bitmap includes a timestamp at the top. On loss of time sync status, a new message "Time Out Of Sync" will be displayed in place of the ISO-formatted timestamp. Here is an example:
