Express Plus

DC Fast Charging Platform

Operation and Maintenance Guide

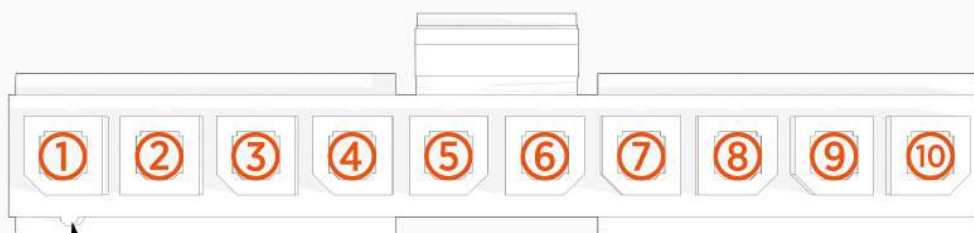
P306-15

Rib to identify the first circuit (pin)

- c. Measure continuity between Pin 4 (CAN_GND) on P312-08 and Pin 10 on P306-15.
4. If any break in continuity is located, then reach out to engineering for a harness replacement. If the issue persists after the above continuity tests, then reach out to engineering for further debugging steps.
